**Flood Control Project Maintenance
Levee Inspections**
LMA District Cover Sheet
Spring 2018 Levee Inspection Results

Reclamation District No. 2075 McMullin

Waterway			Bank	Unit Miles
Unit No. 01 San Joaquin River			Right	7.45
	Spring (March - May)	Summer (June - August)	(September - November) Fall	Winter (December - February)
Unit Maintenance Rating (Fall Only)				
Date of Inspection	5/24/2018 - 5/24/2018			
DWR Inspector	Richard Willoughby			
Accompanied By	Loren Haworth			
	Brian Mizuno

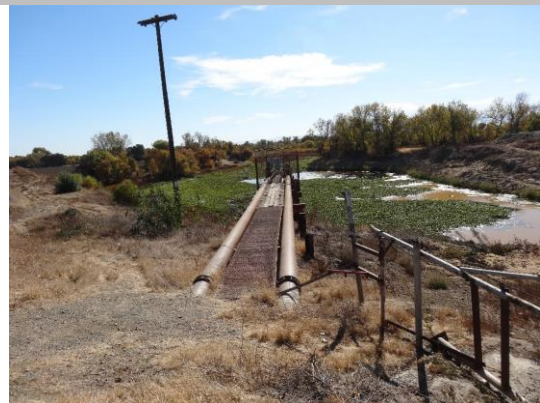
Photo 1 of 3 : UCIP_SP_2018_50209_45603.jpg

Comment Code						
Inspector Comment						
FS_ID:50209 DS_ID:24739 EP_NO: N/A Repair Type: Non-Urgent Crossing Status: Found UCIP Comments: - flap gates in concrete box on LS toe have failed and are open. Rusted through flapgate may indicate condition of interior of pipe. FIELD_STRUCT_DESC: 1 of 2: 16-inch steel irrigation discharge pipe through the levee, 8 feet below the crown. Electrical conduit through the levee. Pump mounted on a pile structure in the river. Wooden walkway to the pump. Siphon breaker and concrete distribution box on the landside (LS) slope. [Additional Reference(s): DWR Levee Log, 2005, 18-inch pipe referenced. USACE San Joaquin O&M Manual 3, December 1968, (HLM 5.16), 18-inch pipe referenced]. FS Date: 6/21/2016

WS view: two pipes, walkway to pump and pile structure in the stream.

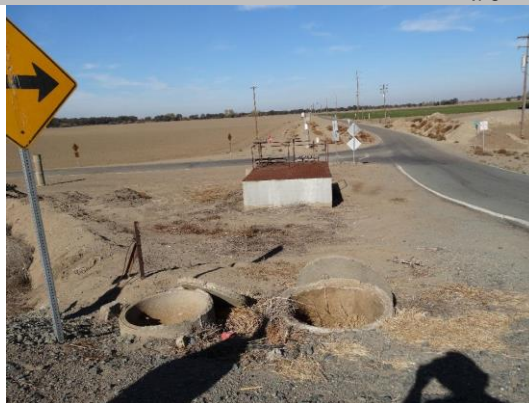
Photo 2 of 3 : UCIP_SP_2018_50209_45602.jpg

Comment Code						
Inspector Comment						
FS_ID:50209						
DS_ID:24739						
EP_NO: N/A						
Repair Type: Non-Urgent						
Crossing Status: Found						
UCIP Comments: - flap gates in concrete box on LS toe have failed and are open. Rusted through flapgate may indicate condition of interior of pipe.						
FIELD_STRUCT_DESC: 1 of 2: 16-inch steel irrigation discharge pipe through the levee, 8 feet below the crown. Electrical conduit through the levee. Pump mounted on a pile structure in the river. Wooden walkway to the pump. Siphon breaker and concrete distribution box on the landside (LS) slope. [Additional Reference(s): DWR Levee Log, 2005, 18-inch pipe referenced. USACE San Joaquin O&M Manual 3, December 1968, (HLM 5.16), 18-inch pipe referenced].						
FS Date: 6/21/2016

LS view: siphon breakers in concrete pipe risers (bottom) on levee slope. Concrete distribution box on levee toe (top).

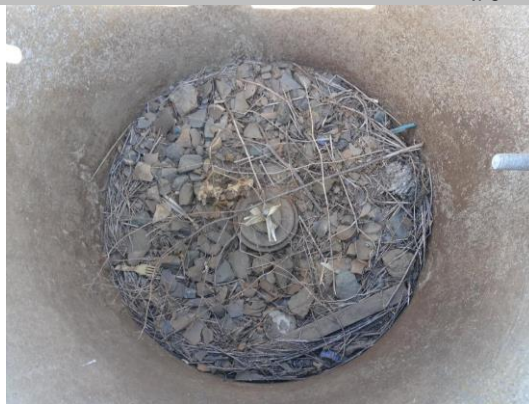
Photo 3 of 3 : UCIP_SP_2018_50209_45605.jpg

LS view: siphon breaker in concrete pipe riser on levee slope.

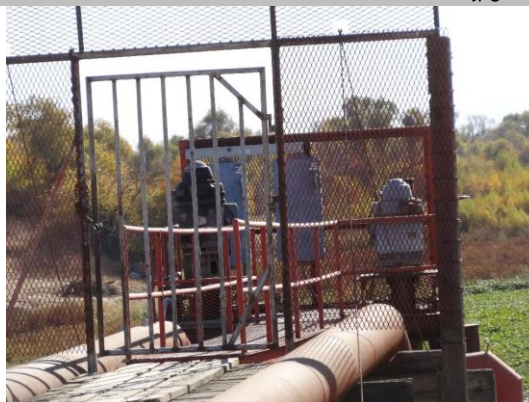
Photo 2 of 3 : UCIP_SP_2018_25184_45607.jpg

LM Start	5.20	Rating **	M	Issue No.	34
LM End	5.20	Issue Type +	En	Location *	
Category	Supplemental			GPS Latitude/Longitude	
				Start	End
Item	DWR UCIP Field Study			37.728848 °	37.728848 °
				-121.275195 °	-121.275195 °
DWR ID					
Comment Code					
Inspector Comment					
FS_ID:25184 DS_ID:24743 EP_NO: N/A Repair Type: Non-Urgent Crossing Status: Found UCIP Comments: Flap gate lid displaced. FIELD_STRUCT_DESC: 2 of 2: 16-inch steel irrigation discharge pipe through the levee, 8 feet below the crown. Electrical conduit through the levee. Pump mounted on a pile structure in the river. Wooden walkway to the pump. Siphon breaker and concrete distribution box on the landside (LS) slope. [Additional Reference(s): DWR Levee Log, 2005, 18-inch pipe referenced. USACE San Joaquin O&M Manual 3, December 1968, (HLM 5.16), 18-inch pipe referenced]. FS Date: 11/13/2013

WS view: closer view of two pumps and platform in the stream.

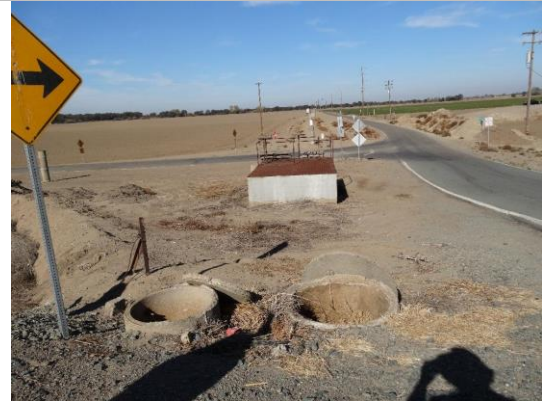
Photo 3 of 3 : UCIP_SP_2018_25184_45606.jpg

LM Start	5.20	Rating **	M	Issue No.	34 (cont)	
LM End	5.20	Issue Type +	En	Location *		
Category	Supplemental			GPS Latitude/Longitude		
				Start	End	
Item	DWR UCIP Field Study			37.728848 °	37.728848 °	
				-121.275195 °	-121.275195 °	
DWR ID						
Comment Code						
Inspector Comment						
FS_ID:25184 DS_ID:24743 EP_NO: N/A Repair Type: Non-Urgent Crossing Status: Found UCIP Comments: Flap gate lid displaced. FIELD_STRUCT_DESC: 2 of 2: 16-inch steel irrigation discharge pipe through the levee, 8 feet below the crown. Electrical conduit through the levee. Pump mounted on a pile structure in the river. Wooden walkway to the pump. Siphon breaker and concrete distribution box on the landside (LS) slope. [Additional Reference(s): DWR Levee Log, 2005, 18-inch pipe referenced. USACE San Joaquin O&M Manual 3, December 1968, (HLM 5.16), 18-inch pipe referenced]. FS Date: 11/13/2013

LS view: siphon breakers in concrete pipe risers (bottom) on levee slope. Concrete distribution box on levee toe (top).

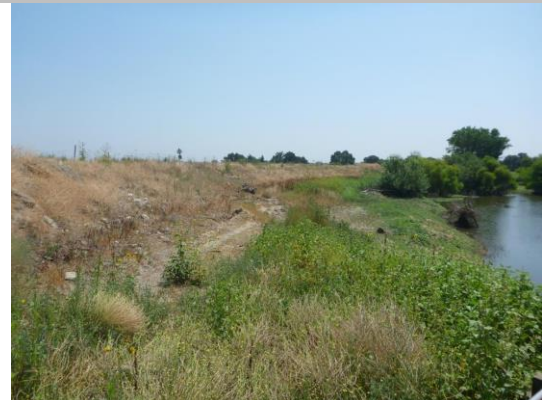
Photo 1 of 3 : LEVAL_SP_2018_578_4248.jpg

LM Start	5.24	Rating **	A/W	Issue No.	21
LM End	5.29	Issue Type +	Ma	Location *	
Category	Supplemental			GPS Latitude/Longitude	
				Start	End
Item	2017 Storm Damage			37.728460 °	37.727799 °
				-121.274671 °	-121.274252 °
DWR ID	DWR_RD2075_01_f _ 2017_21				
Comment Code					
Inspector Comment					
Levee Evaluation Comments					
Description:Slope protection repairs are needed along the waterside slope due to erosion and riprap displacement from high water. Based upon levee inspections, it was determined the waterside levee slope is eroding, deteriorating, and degrading. The eroded levee sections need to be restored back to design standards to prevent further deterioration and damage.					
Site ID No:578					
Site Designation:LMA-484					
Repair Type: Erosion					
Rating:Area of Concern					
Field Date:8/10/2017					
Notes: Paved road on levee.

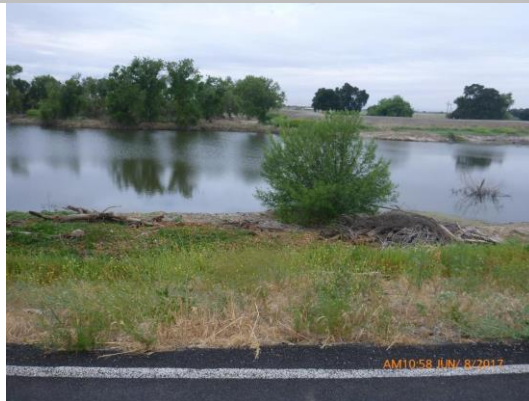
Photo 1 of 3 : LEVAL_SP_2018_79_1331.jpg

LM Start	5.26	Rating **	A/W	Issue No.	23
LM End		Issue Type +	Ma	Location *	
Category	Supplemental			GPS Latitude/Longitude	
				Start	End
Item	2017 Storm Damage			37.728216 °	°
				-121.274434 °	°
DWR ID	DWR_RD2075_01_f_2017_23				
Comment Code					
Inspector Comment					
Levee Evaluation Comments					
Description:					
Site ID No:79					
Site Designation:LMA-33					
Repair Type: Erosion					
Rating:Area of Concern					
Field Date:6/8/2017					
Notes: no damage present

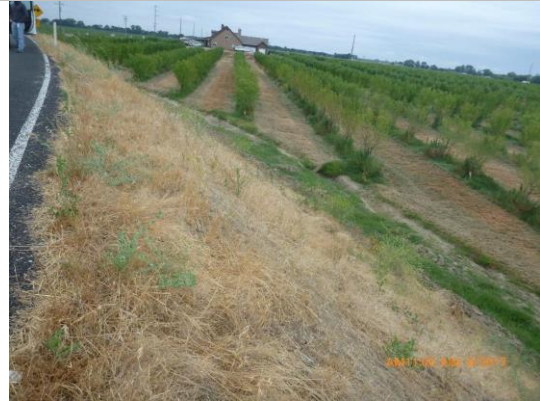
Photo 3 of 3 : LEVAL_SP_2018_79_1337.jpg

LM Start	5.26	Rating **	A/W	Issue No.	23 (cont)	
LM End		Issue Type +	Ma	Location *		
Category	Supplemental			GPS Latitude/Longitude		
				Start	End	
Item	2017 Storm Damage			37.728216 °		°
				-121.274434 °		°
DWR ID	DWR_RD2075_01_f_2017_23					
Comment Code						
Inspector Comment						
Levee Evaluation Comments						
Description:						
Site ID No:79						
Site Designation:LMA-33						
Repair Type: Erosion						
Rating:Area of Concern						
Field Date:6/8/2017						
Notes: no damage present

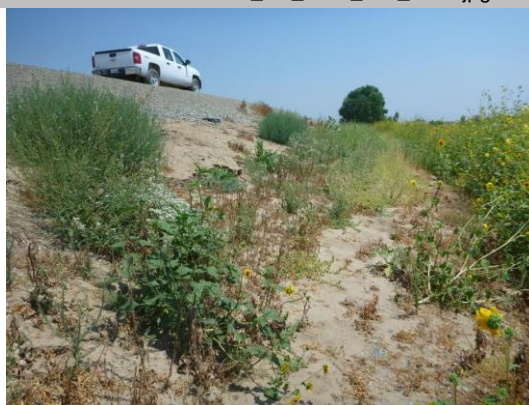
Photo 1 of 3 : LEVAL_SP_2018_579_4263.jpg

LM Start	5.87	Rating **	A/W	Issue No.	28
LM End	6.33	Issue Type +	Ma	Location *	
Category	Supplemental			GPS Latitude/Longitude	
				Start	End
Item	2017 Storm Damage			37.721710 °	37.720960 °
				-121.267490 °	-121.259830 °
DWR ID	DWR_RD2075_01_f _ 2017_28				
Comment Code					
Inspector Comment					
Levee Evaluation Comments					
Description:Slope protection repairs are needed along the waterside slope due to erosion and riprap displacement from high water. Based upon levee inspections, it was determined the waterside levee slope is eroding, deteriorating, and degrading. The eroded levee sections need to be restored back to design standards to prevent further deterioration and damage.					
Site ID No:579					
Site Designation:LMA-485					
Repair Type: Erosion					
Rating:Area of Concern					
Field Date:8/10/2017					
Notes: Berm present on LS. LMA 486 is combined with this site.

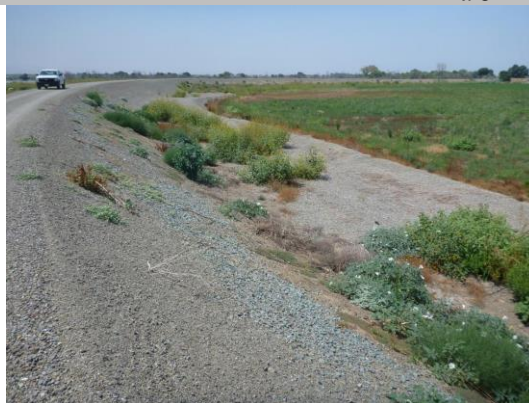
Photo 2 of 3 : LEVAL_SP_2018_579_4264.jpg

Comment Code					
Inspector Comment					
Levee Evaluation Comments					
Description:Slope protection repairs are needed along the waterside slope due to erosion and riprap displacement from high water. Based upon levee inspections, it was determined the waterside levee slope is eroding, deteriorating, and degrading. The eroded levee sections need to be restored back to design standards to prevent further deterioration and damage.					
Site ID No:579					
Site Designation:LMA-485					
Repair Type: Erosion					
Rating:Area of Concern					
Field Date:8/10/2017					
Notes: Berm present on LS. LMA 486 is combined with this site.
